**Public Works/Facilities Committee Meeting Agenda**  
**Monday, February 8, 2016 - 6:30 P.M.**  
**Kenosha County Center, 19600 75<sup>th</sup> Street, Conference Room B**  
**Bristol, WI 53104**

**RE:** Summary and Report of Structural Condition of the Pre-Trial Facility

Please find attached the complete report as prepared by KPFF Engineering regarding the investigation of a range of cracks throughout the Pre-Trial Facility.

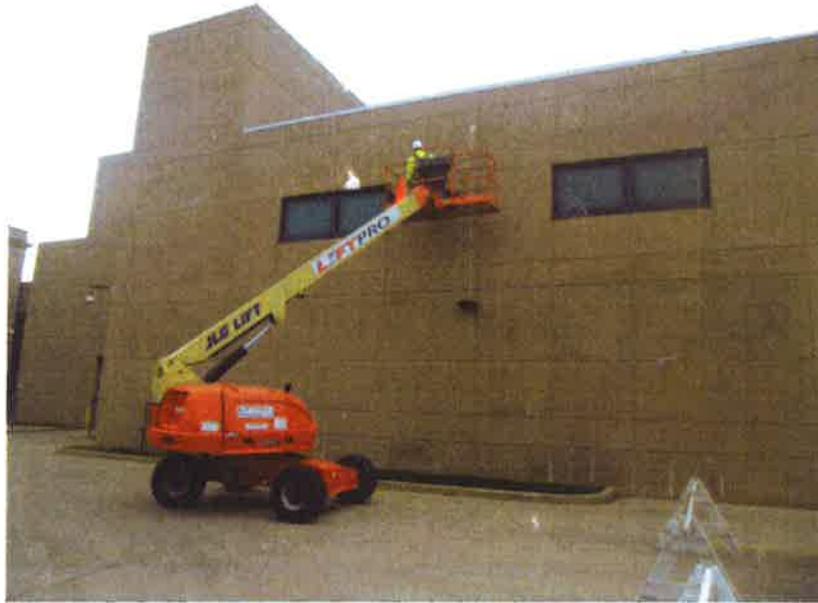
Photo 1 – Inspection Access

Nine “drops” were performed to evaluate the exterior façade. Each drop consisted of a complete inspection of a section of panels, between adjacent joints, from the top of the parapet to the ground, as shown in Photos 1 and 2. Access to reach the entire height of the façade was provided by a 60-foot JLG man-lift, with parking restrictions imposed along the east side of 10th Ave. and in the parking lot north of the Pre-Trial Facility. Figures 1 and 2

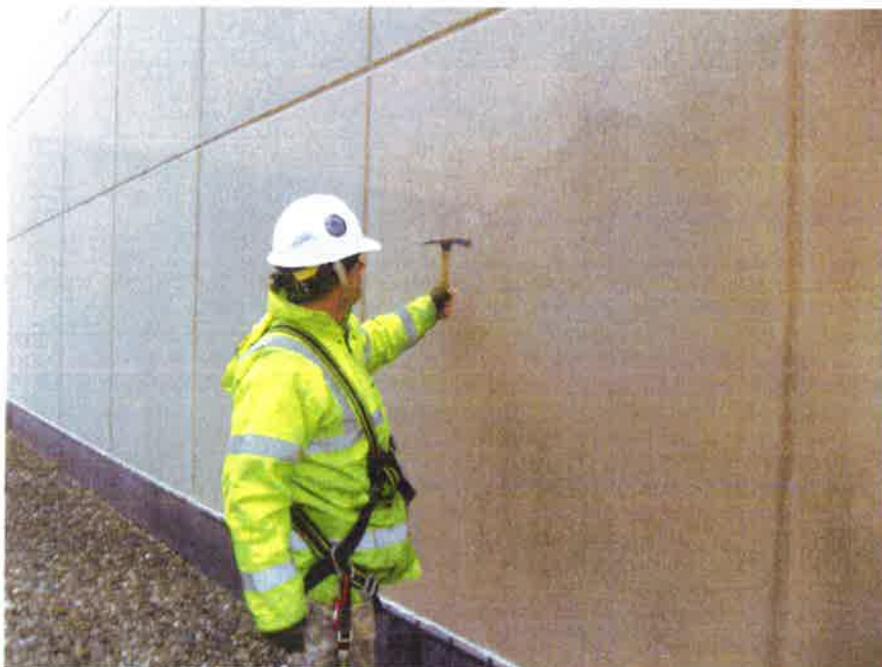
Photo 3 – Hammer Sounding

To accomplish the objectives, KPFF utilized visual inspection including photographic documentation, crack mapping, and crack width measurements; and non-destructive testing including hammer sounding, and Ground Penetrating Radar (GPR). The inspection methodologies and results are described in the following sections.

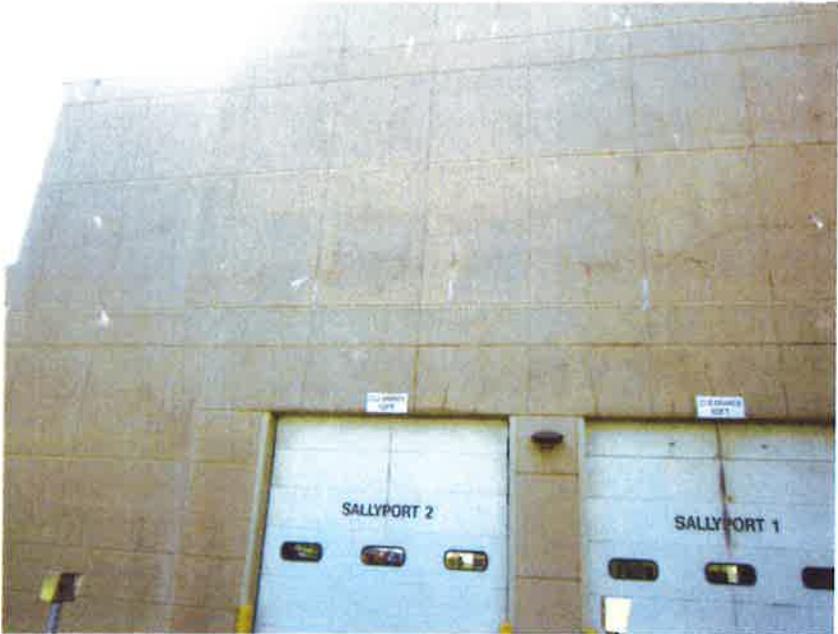
Photo 5 – Typical Panel Cracking

**Panel Cracking and Efflorescence** - The most prominent cracking throughout the façade is fairly linear block pattern cracking (see Photos 5 and 6). The cracks are tight, ranging in width from 0.007 to 0.015 inch. These are the cracks which become accentuated by moisture after a rain event and are not uncommon for these types of precast sandwich panels. They do not indicate distress or structural failure of the panels. The cracking is attributed to out-of-plane forces acting on the panels from wind loading or thermal movement. This loading causes tension in the outer surface of the concrete which then cracks, allowing the panel reinforcement to engage as designed. Additionally, the majority of the architectural reveal joints in the panels are cracked (see Photo 9). These types of decorative joints are common in precast panels and typically crack because they are an intentional stress concentration point for any out-of-plane flexure from lateral loading.

The cracks and efflorescence mainly represent an aesthetic concern. Because there is no rust staining evident on the surface of the panels, moisture is likely not reaching the depth of the reinforcement, which would initiate corrosion of the reinforcing steel. There are several options to consider with regard to addressing the panel cracking. First, thorough repair of the cracks would involve routing and sealing the cracks to prevent further moisture intrusion, crack growth, and efflorescence. This would be an expensive and time-consuming repair. Additionally, routing and sealing the cracks will make them permanently and highly visible, rather than only visible after rain, as they are currently. A second option is to paint the panels or apply a surface sealer. This will improve aesthetics but is not as durable a remediation, and as the panels move the cracks may reopen, requiring more frequent reapplications. The final option is the "do nothing" alternative. As mentioned, the cracking is aesthetic only and consideration of budgetary constraints and pros and cons of the other alternatives may make this a viable option.

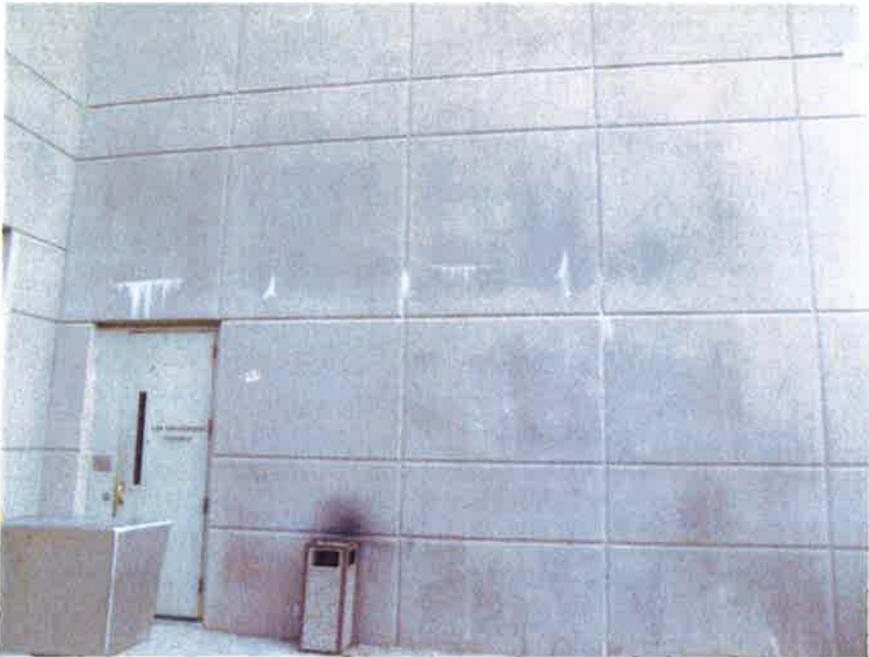
Photo 6 – Typical Efflorescence

The white chalky powder visible along some of the cracks is efflorescence of the concrete. Efflorescence discolors the concrete finish and is caused by water entering the cracks and encountering soluble deposits such as salts. The water then leaches out of the cracks and evaporates, leaving the deposits on the concrete surface. Efflorescence is not damaging to the panels.

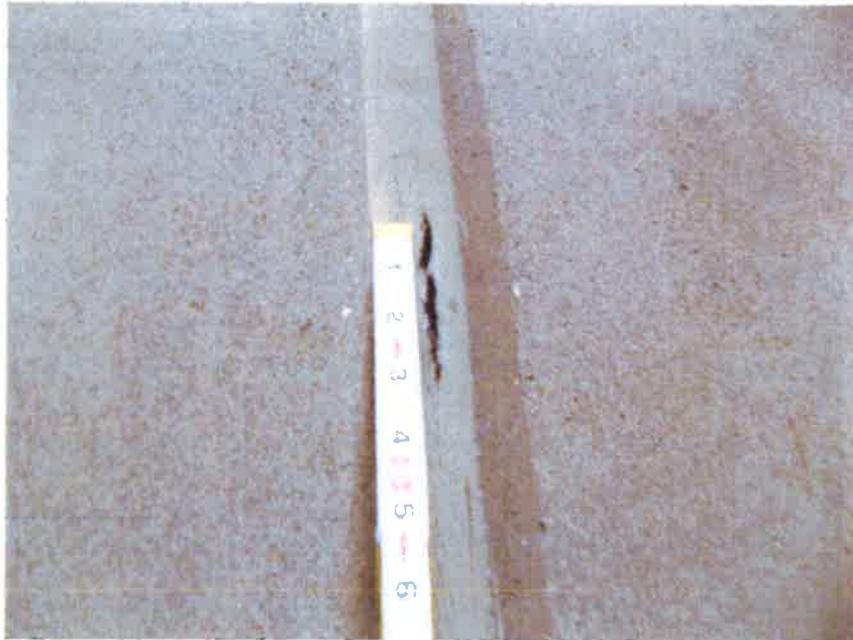
Photo 7 – Joint Sealant Failure

**Joint Sealant Failing** - The exterior joint sealant between precast panels has reached the end of its expected service life and is beginning to fail in several areas (see Photos 7 and 8). We recommend replacing all of the joint sealant throughout the exterior façade. Although widespread sealant failure has not yet occurred, spot replacement of failed sealant is not recommended due to its age. If cost is prohibitive to replace of all the joints throughout the façade at once, then we recommend a staggered program, perhaps replacing the joint

material in one elevation at a time. If this course is chosen, we recommend beginning with the west elevation, then east, south, and north. Budgetary estimate for joint replacement is between \$45,000 to \$55,000, including repair of corner spalls.

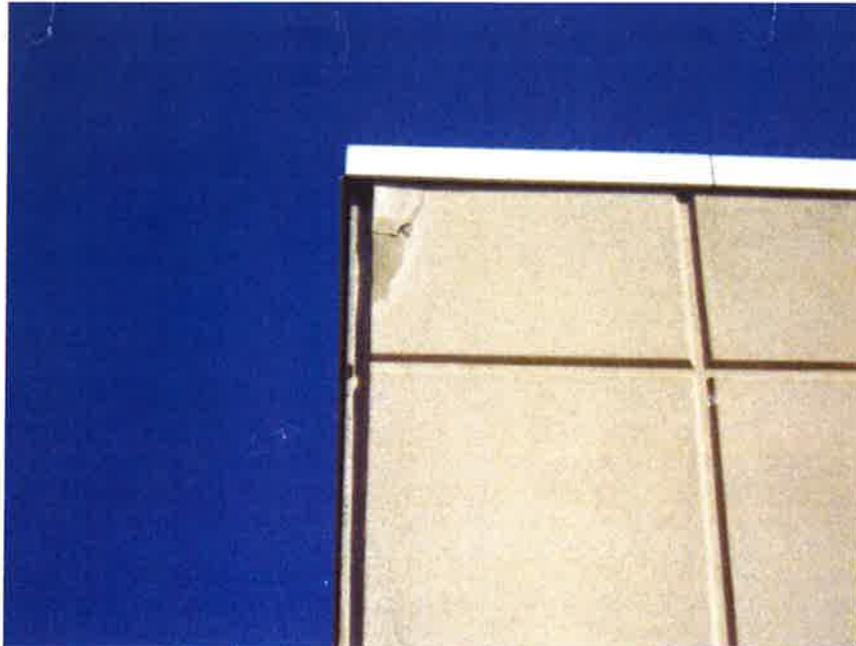
Photo 10 - Corner Spall

**Corner Spalls** – Spalling of concrete is a surface defect caused by forces within the concrete. There are two locations where corner spalls have developed on panels. One is on the upper-north corner of Panel 139 and the other is on the lower-west corner of Panel 137 (see Photos 10 and 11). Both of the spalls are on upper levels set back from the lower-level roof edge and are a minimal falling hazard to pedestrians. However, these areas should be repaired as soon as practical by removing the spalled concrete and patching with a suitable material. These repairs should be included when the joint replacement is undertaken and would likely add . Th

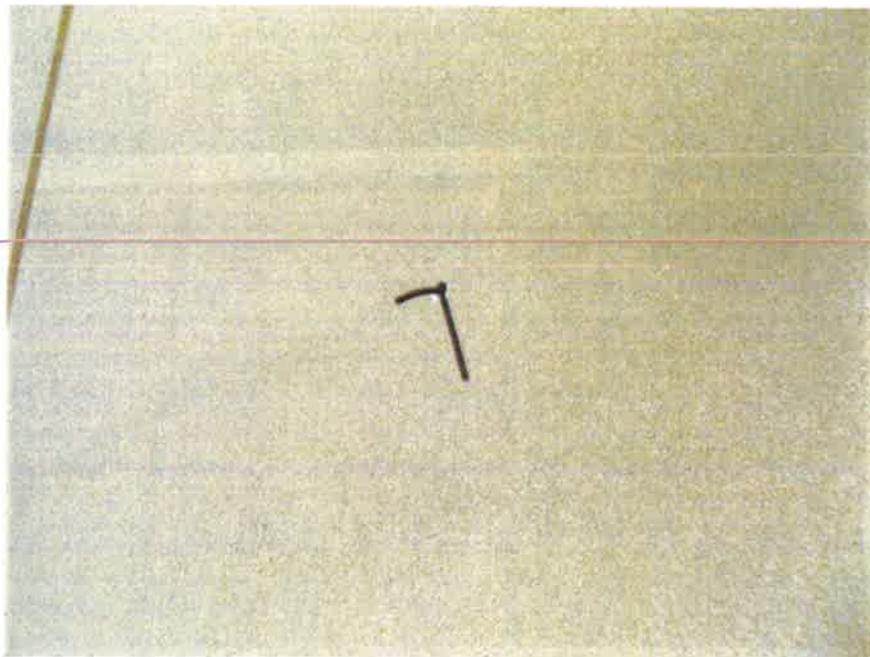
Photo 12 – Abandoned Cable

**Miscellaneous Items** – Several miscellaneous items were noted, including an un-caulked abandoned cable penetration (Photo 12), minor rust staining from shallow cover over reinforcement (Photo 13), a previous repair of a hidden panel-to-panel connection that is cracking (Photo 14), and small areas of potential delaminations.

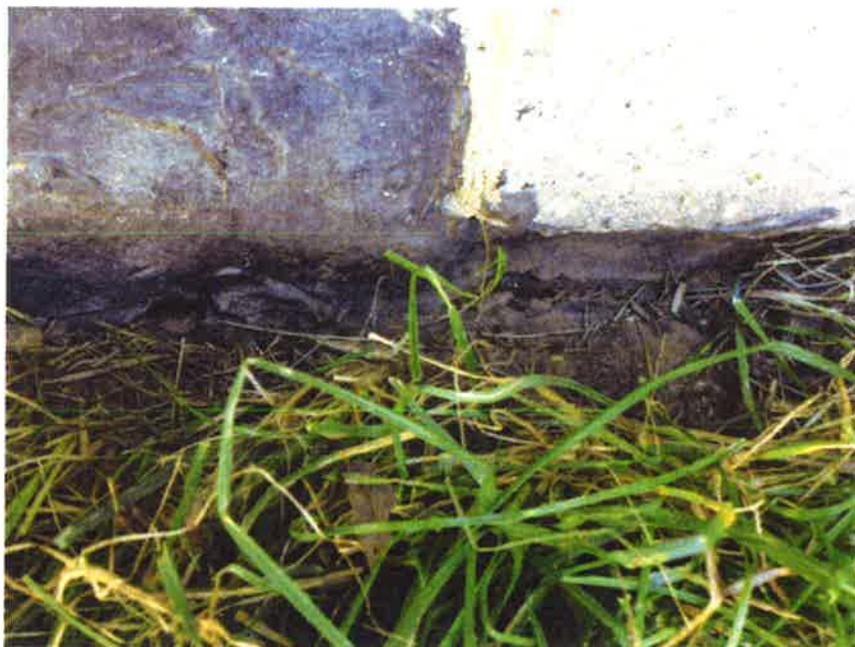
Photo 15 – Holes in Water Barrier Membrane at Ground Line

Water appears to be entering the building at the joint between the lower level precast panel and the top of slab/foundation wall. Holes were observed in joint material or water-proofing membrane at the ground line between the precast panel and slab/foundation wall (see Photo 15). The water is then running down the inside of the west wall and also progressing east, ~~likely along the interface beneath the first floor slab and stay in place metal forms, until~~ it reaches Line B, where it drips out of the forms along the beam and then through the ceiling into the holding cell. Water stains were observed on the west face of the beam at Line B in the ceiling plenum. On the exterior, the landscaping in this area has created a small swale or depression in the grass just to the north of the southwest building entrance. Water cannot drain out of this area north toward the existing drain inlet, and therefore accumulates which adds to the problem (see Photo 16).

The area along the west foundation wall needs to be excavated to expose the full length of the joint between Panel 10 and top of slab/foundation wall to evaluate the condition of the joint sealant or water barrier membrane between the panel and slab. The seal should be replaced and/or repaired as necessary. After the joint has been repaired, the grass area along the west wall should be re-graded to allow water to flow north to the existing drain inlet located between Column Lines 9 and 10, or a stub drain should be installed to drain water from the low area to the existing inlet. Budgetary estimate for addressing the basement leak is \$5,000 to \$8,000.

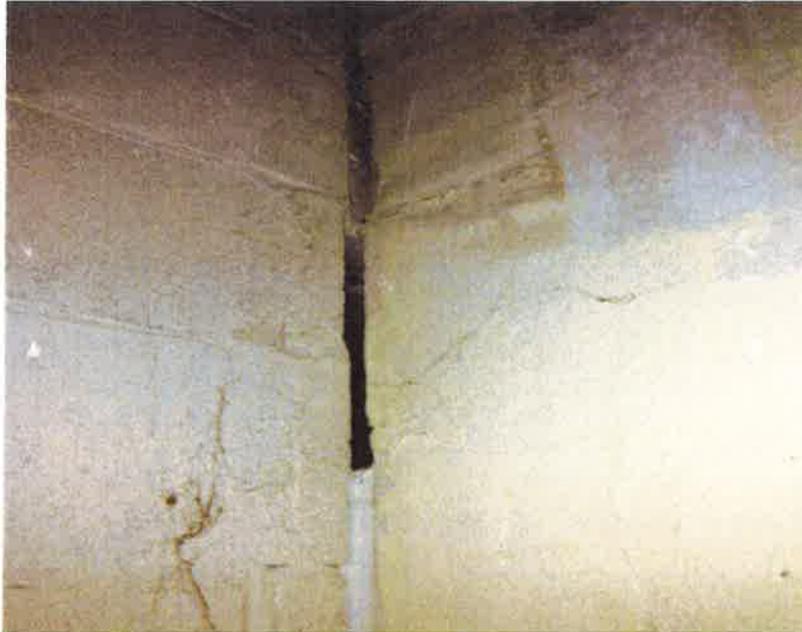
Photo 17 – Missing Sealant between Precast Panel and CMU Wall above First Floor Office

Although access limitations only permitted observation of a single interior panel/CMU wall interface above the first floor office, this location is missing a section of joint sealant (see Photo 17). It is likely that this condition persists at other joints in the vicinity of the reported draft. Additionally, the joint between the precast panel and the ceiling of the locker room has separated slightly (see Photo 18), indicating differential movement between the ceiling and panel has occurred. All interior joints should be fully sealed between the precast panels and adjacent walls. Because this may require removal of drywall at considerable expense and inconvenience, we recommend first attempting to seal all accessible joints through the ceiling space. If this is unsuccessful in eliminating the reported draft, then small inspection holes could be made in the walls of the office and ceiling of the locker room to determine the condition of those joints. We also recommend re-caulking the window on the first level of the west wall. Finally, resealing the exterior panel joints as recommended above should also help to reduce drafts through the joints.

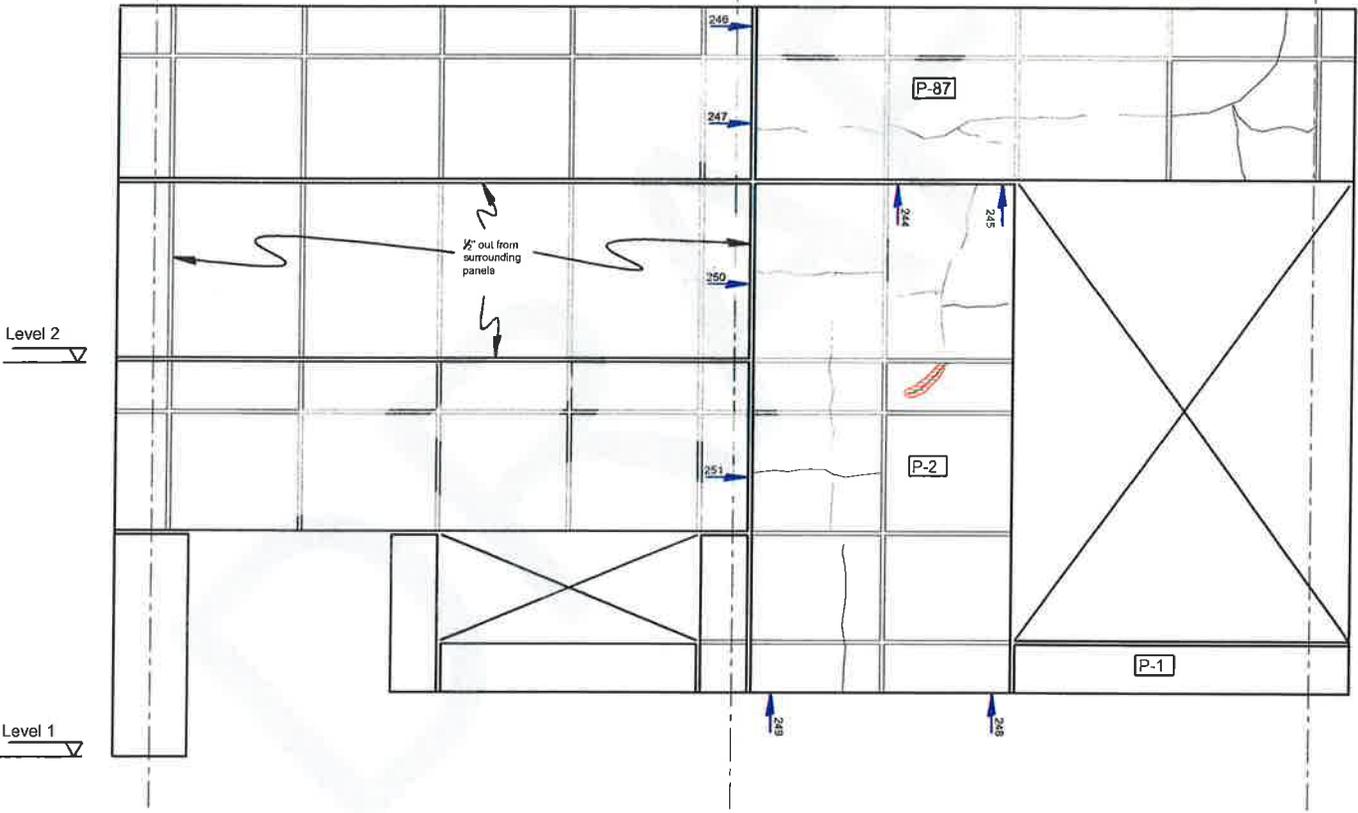
South Elevation  
Drop 1

For each panel of each drop, the panels were visually inspected to identify all cracking, spalls, and any other miscellaneous defects present on the panels. The panels were also hammer sounded to locate potential areas of delaminations or voids that are not visually discernable (see Photo 3). Additionally, GPR was performed selectively during the inspection to identify depth and spacing of steel reinforcement in the panels (see Photo 4). GPR scans were taken horizontally and vertically for the full width and height of the panels. The results of the exterior inspection are documented in Figures 3 through 11.
